Improvement Location Report

That on May 21, 2007, I made an inspection of the premises situated at, 185 Coyote Loop in Hondo Mesa, Taos County New Mexico.

Briefly described as Lot 19 of the River View Acres Subdivision.

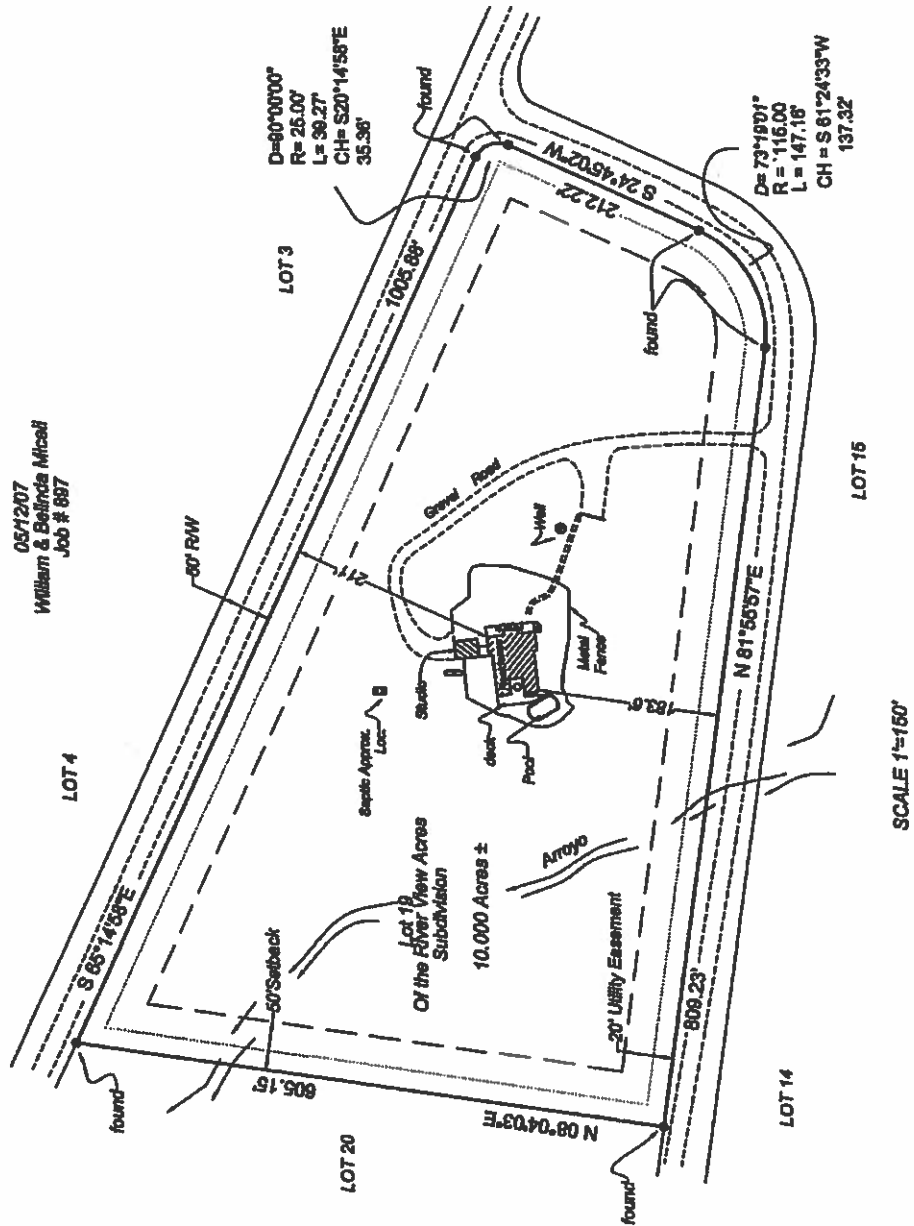
1. Evidence of right of way, old highways or abandoned roads, lanes trails or driveways, sewer, water, gas or oil pipe lines or a crossing said premises (show location, if none visible, so indicate).
See Sketch

4. Overhead utility poles, anchors, pedestals, wires or lines overhanging or crossing said premises and serving other properties (show Location)
As illustrated on attached sketch

5. Joint driveways or walkways, joint garages, party walls or right of support, steps or room in common or joint garages.
None visible
6. Apparent encroachments. If the building, projections or cornices thereof, or signs affixed thereto, fences or other indications of occupancy appear to encroach upon or overhang inspected premises. Specify all such (show location.)
See Sketch

7. Specific physical evidence of boundary lines on all sides.
All Survey Monument found
8. Is the property improved? (if structure appears to encroach or appears to violate setback lines, show approximate distances.)
See Sketch

9. indication of recent building construction, alterations or repairs.
See Sketch.
10. Approximate distance of structure from at least two lines must be shown.
As illustrated on attached sketch.
